## Service Bulletin

SB08-53-01

ENGINE COWLING ALIGNMENT INSPECTION AND MODIFICATION

Model	Serial Numbers
172R	17280725 thru 17281262
172S	172S8202 thru 172S10006

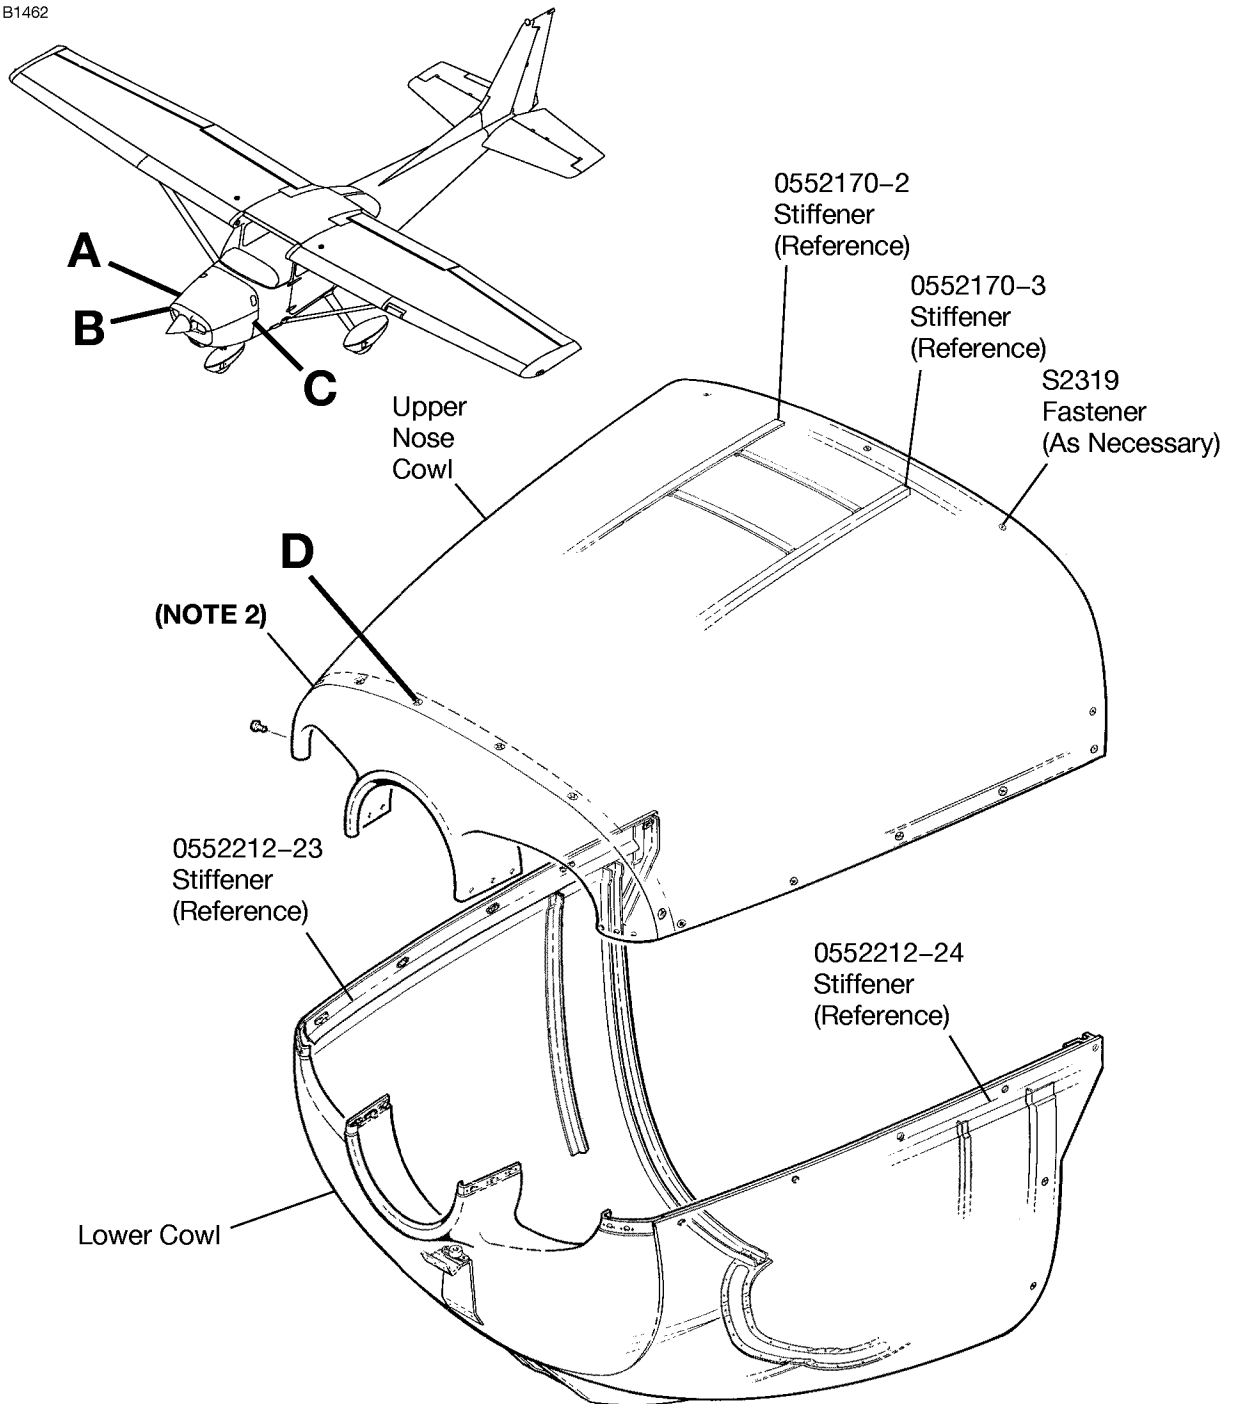
Figure 1. Cowling Alignment Fit and Clearance (Sheet 1)

- (7) Install the upper and lower cowlings and do Steps 21A through 21A(6) again until there is necessary clearance.
- 22. (Refer to Figure 1, Detail A.) Do a visual inspection of the upper engine cowl to look for signs of wear on the forward S2319 Cowl Fasteners, for signs that the forward S2319 Cowl Fasteners are going to pull through or have pulled through the upper engine cowl, and for wear on the forward doubler on the bottom side of the upper engine cowl.

- A. If one or more of the forward S2319 Cowl Fasteners are worn or have pulled through the upper engine cowl and the S2319-61 Grommet hole is larger than 0.70 inch, if a repair doubler has been installed, or if the forward doubler on the bottom side of the upper engine cowl is worn through and into the upper engine cowl skin, you must remove and discard the upper cowl and install a new 0552212-245 (with excess material) Upper Cowl Assembly. Go to Step 23.

**NOTE 2:** Do a visual inspection of this area. Look for S2319-61 Grommets and S2319 Cowl Fasteners that are pulled through. Also look on the doubler on the bottom side of the cowl for wear that has gone through the doubler and into the cowl.

- B. If the forward S2319 Cowl Fasteners are not worn or pulled through the upper engine cowl and the S2319-61 Grommet hole is 0.70 inch or smaller, and if the forward doubler on the underside of the upper engine cowl is not worn through and into the upper engine cowl skin, go to Step 24.

26. (Refer to Figure 1, Detail A.) Examine the aft end of the 0552212-23 and the 0552212-24 Stiffener on the upper right and upper left sides of the lower cowling, and examine the firewall flange and forward fuselage skin for signs that they have worn against the 0552212 Stiffener.

A. Trim the aft end of the 0552212-23 and 0552212-24 Stiffener at a 45° angle as necessary if the stiffener has worn against the firewall flange or forward fuselage skin.

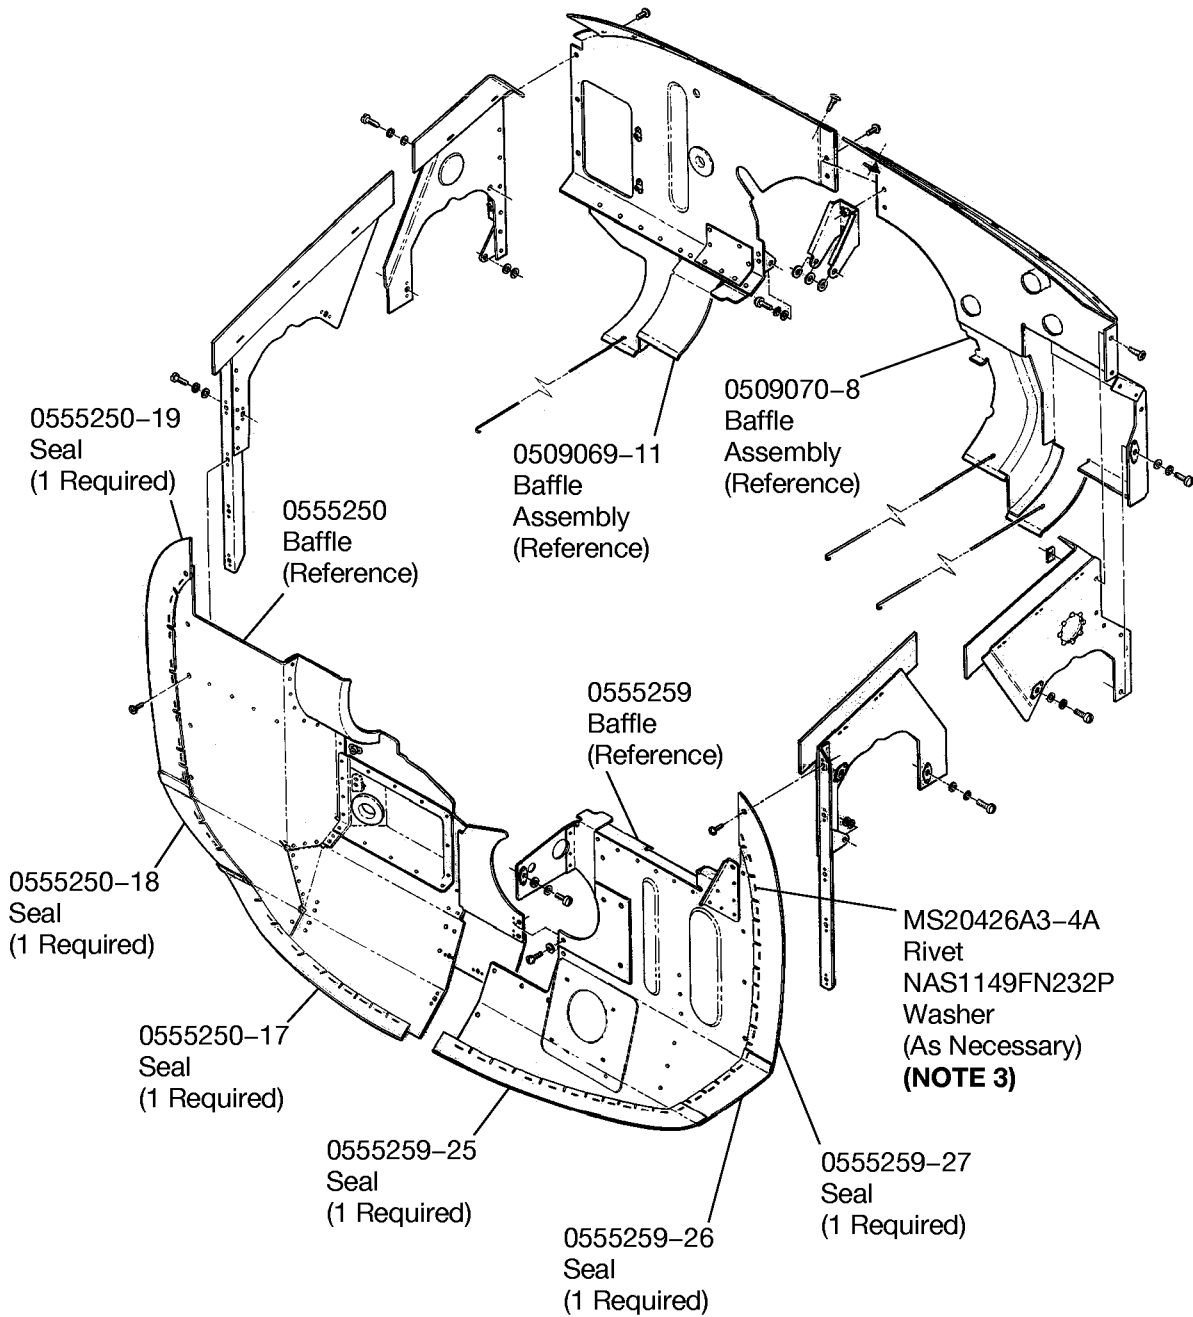
Figure 1. Cowling Alignment Fit and Clearance (Sheet 2)

D. (Refer to Figure 1, Detail A and Detail B.) Look for evidence of wear between the upper cowling stiffener and the metal part of the baffles. Record all affected areas.

**NOTE 3:** New seal installation.

- B. (Refer to Figure 1, Detail B.) Replace the seals on the forward right hand baffle assembly with new seals. (Refer to the Model 172R/172S Illustrated Parts Catalog, Chapter 71, Engine Baffles Installation.)

C. (Refer to Figure 1, Detail B.) Replace the seals on the forward left hand baffle assembly with new seals. (Refer to the Model 172R/172S Illustrated Parts Catalog, Chapter 71, Engine Baffles Installation.)

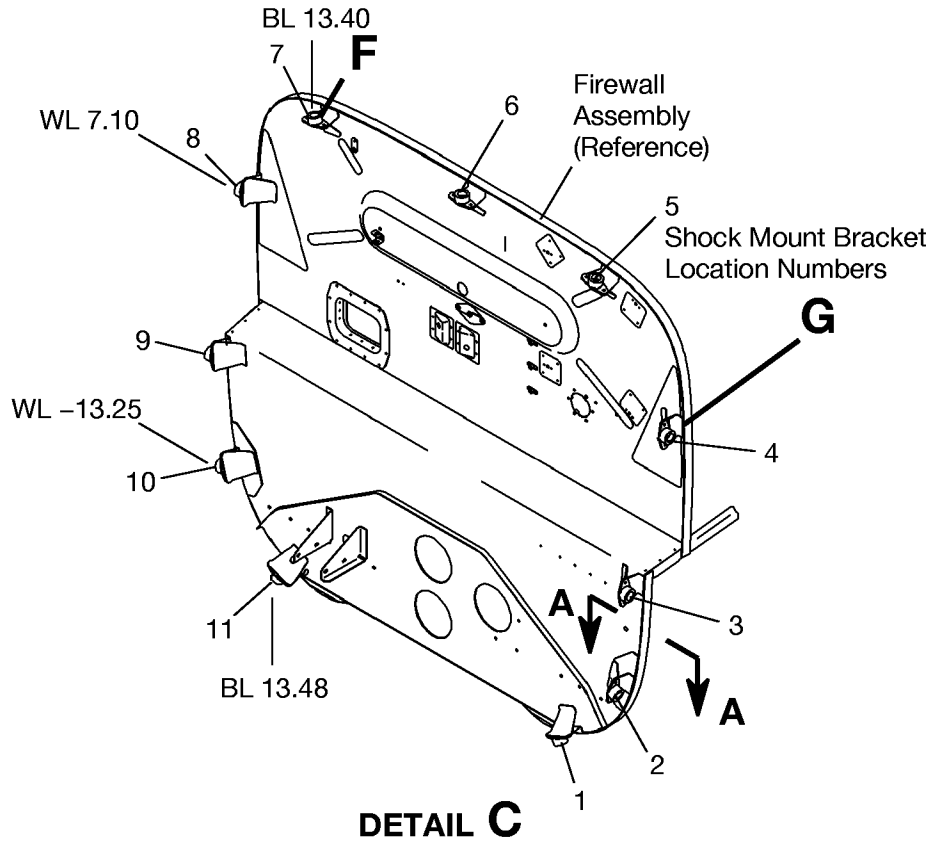
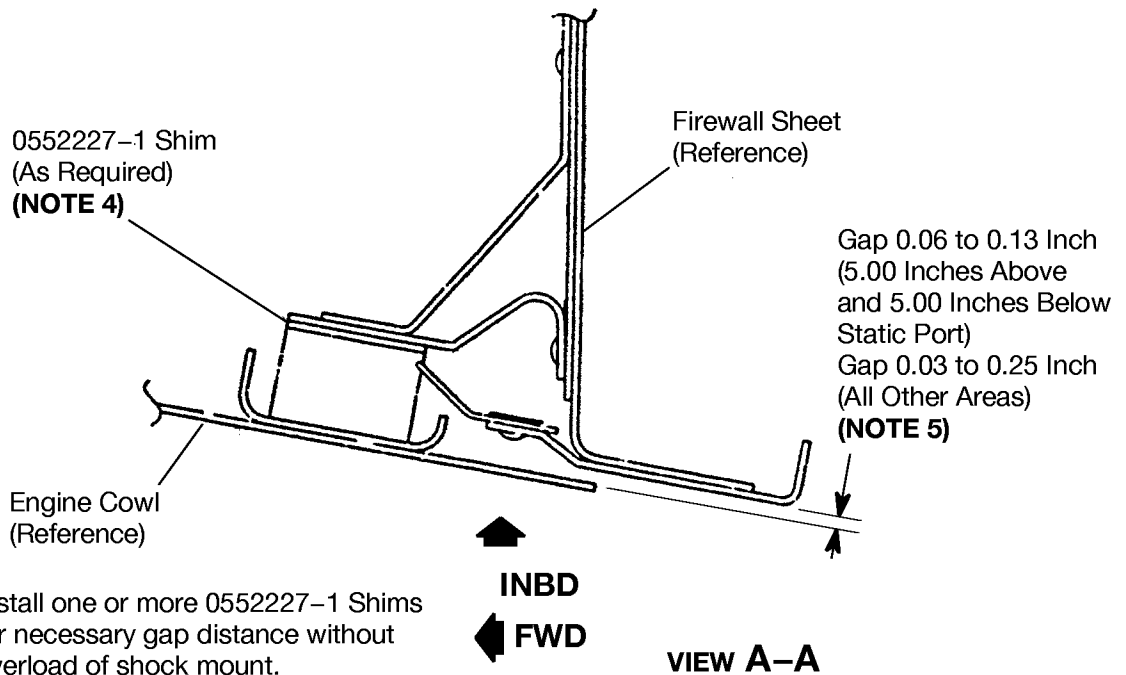
Figure 1. Cowling Alignment Fit and Clearance (Sheet 3)

- C. (Refer to Figure 1, Detail C and View A-A.) Measure the gap between the aft edge of the upper and lower cowlings, and the forward fuselage skin.

**NOTE:** The allowable gap is 0.03-inch to 0.25-inch, with 0.12-inch gap preferred. In the area within 5.0 inches above and 5.0 inches below the static port (left side only, the allowable gap is 0.06-inch to 0.13-inch with 0.10 inch preferred).

**NOTE 5:** Measure gap between nearest cowling fuselage skin or fastener.

**NOTE 4:** Install one or more 0552227-1 Shims for necessary gap distance without overload of shock mount.

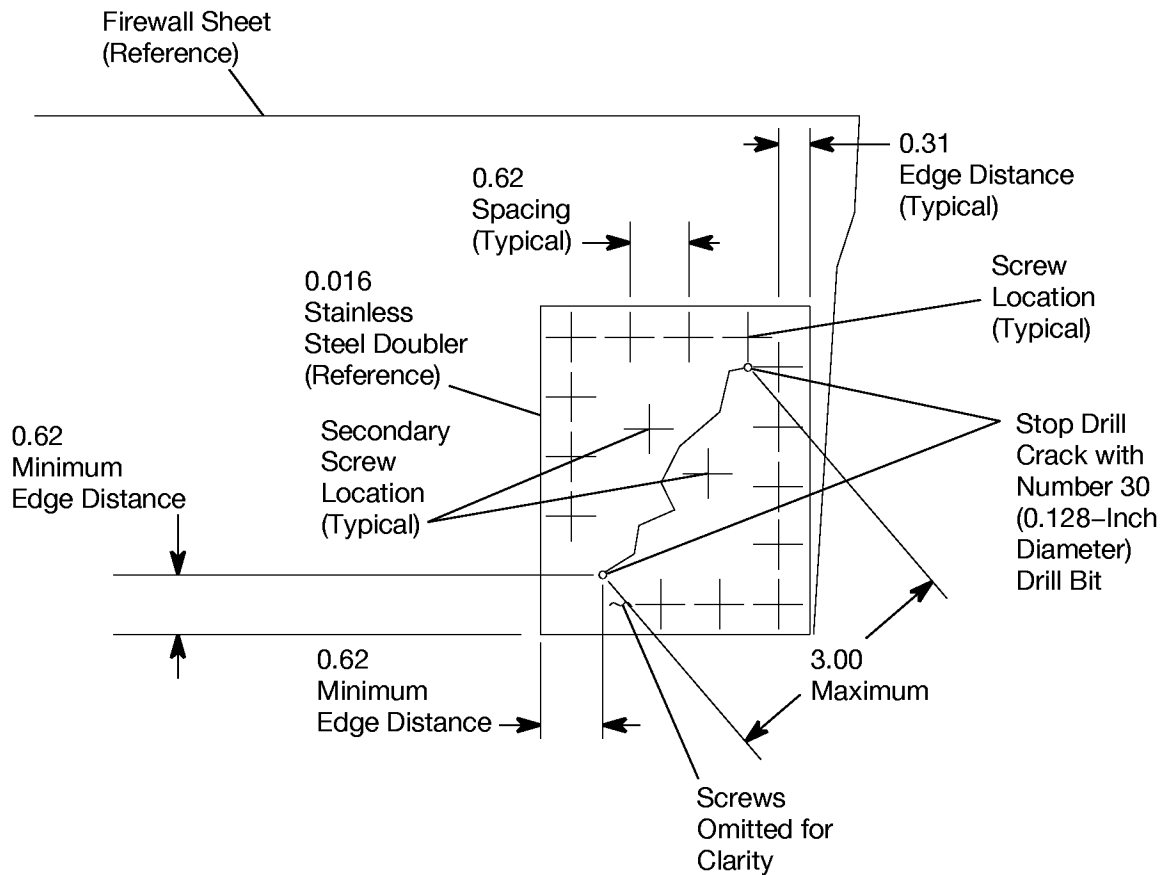
**VIEW A-A**  
 Typical Doubler  
 Installation Shown

- B. Look for firewall cracks adjacent to the cowling shock mount brackets. If you do not find cracks, go to Step 10. If you find cracks, record all affected areas and repair the cracks as follows:

- (2) Measure overall crack(s) length.

- (k) Deburr holes in firewall and doubler.
  - (l) (Refer to Figure 4, View A-A.) If the mid section of the crack is more than 0.62 inch from the closest screw, use of a secondary screw location will be necessary.

- (4) (Refer to Figure 4, View A-A.) If crack length is 3.00 inches or less:
- (a) Remove the pilot and copilot seats. (Refer to Model 172 Series 1996 And On Maintenance Manual, Chapter 25, Flight Compartment - Maintenance Practices.)
  - (b) Remove the pilot and/or copilot rudder pedal shields as necessary.
  - (c) Remove and keep carpeting and soundproofing material from the lower firewall as necessary to get access to lower firewall. (Refer to Model 172 Series 1996 And On Maintenance Manual, Chapter 25, Soundproofing and Insulation - Maintenance Practices.)

- (d) Stop drill crack(s) using a Number 30 (0.128 inch diameter) drill bit.
- (e) (Refer to Figure 4, View A-A.) Fabricate a doubler similar to the one shown, ensuring allowance for minimum edge distance spacing of screws. Doubler material is to be 0.016 inch 301 Annealed Stainless Steel (per MIL-S-5059 or equivalent) with 0.030 inch minimum bend radius when necessary. Acceptable alternate doubler materials are 302, 304, or 321 Annealed Stainless Steel sheet per AMS5516 or equivalent.

**NOTE:** (Refer to Figure 4, Detail A.) The doubler may be installed on the aft side of the firewall in areas where the 0513109-90 Reinforcement is installed on forward side of firewall.

**NOTE:** Make sure that a minimum of 0.31-inch edge distance from edge of crack and minimum screw spacing of two times the edge distance is kept.
