## Service Bulletin

SB08-53-01

ENGINE COWLING ALIGNMENT INSPECTION AND MODIFICATION

Model	Serial Numbers
172R	17280725 thru 17281262
172S	172S8202 thru 172S10006

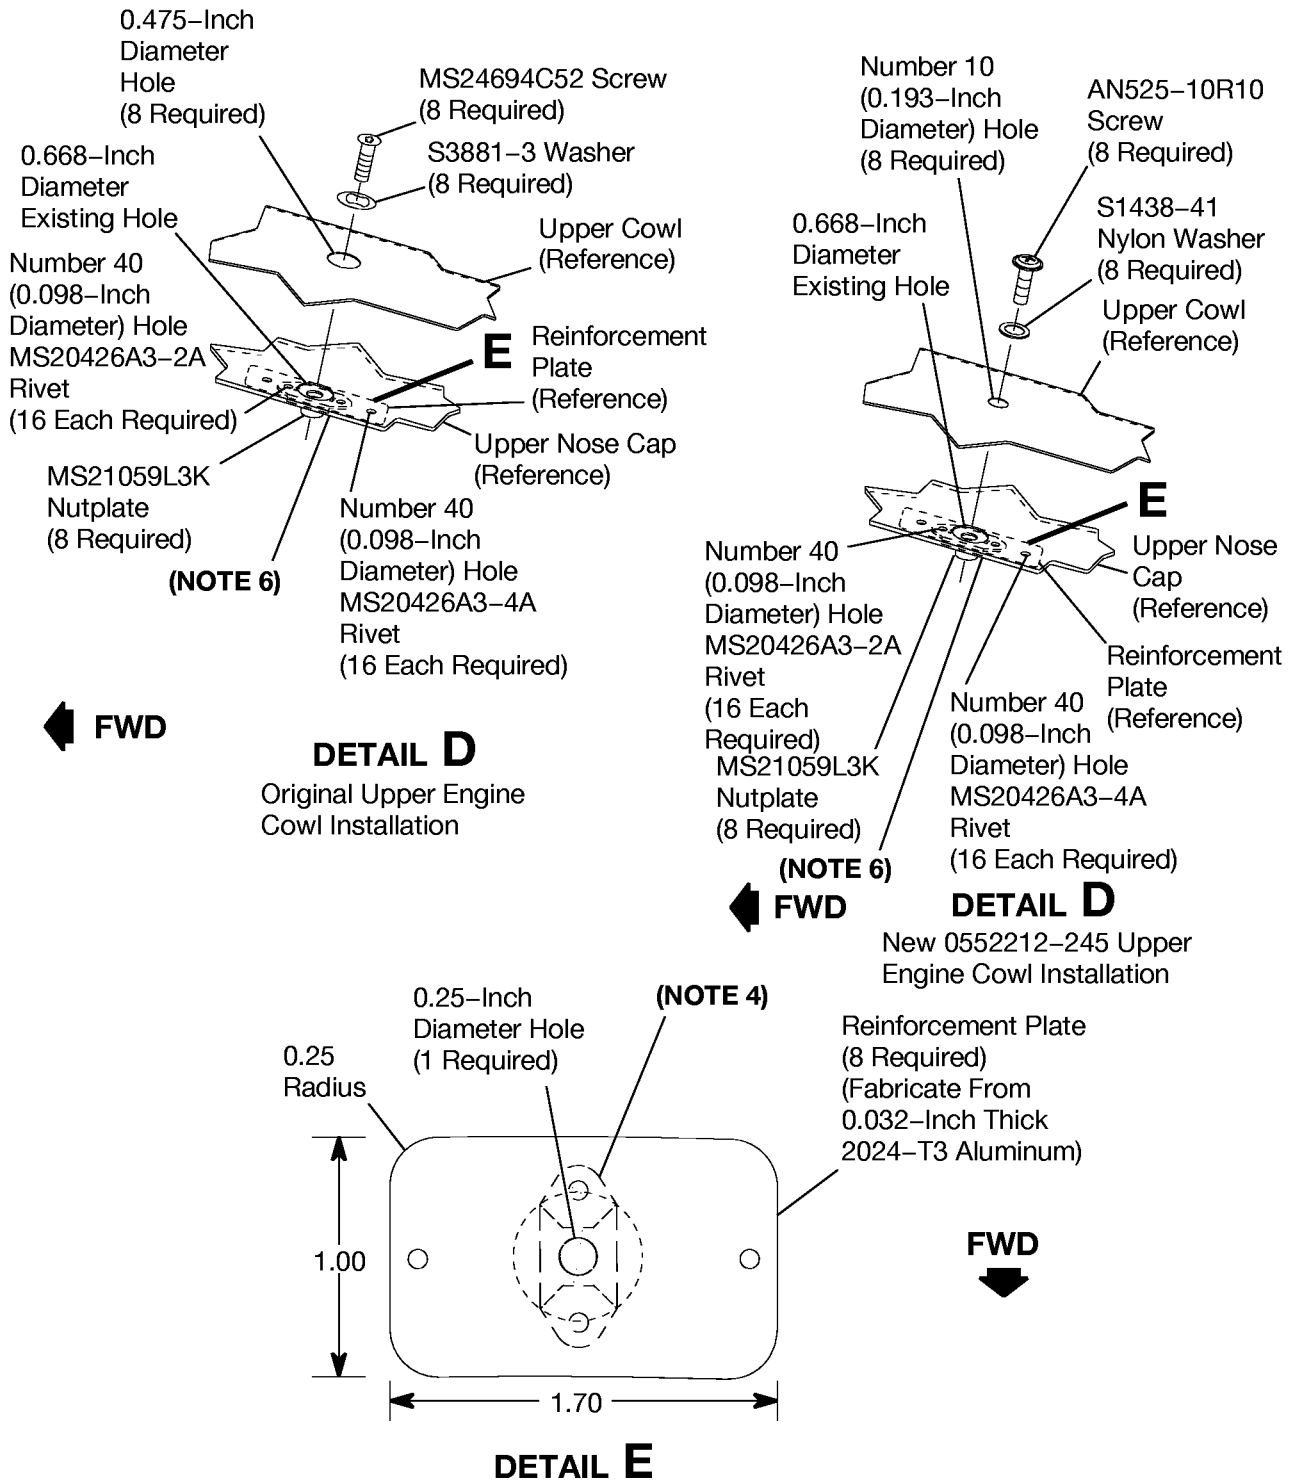
Figure 1. Cowling Alignment Fit and Clearance (Sheet 3)

**NOTE 2:** Do a visual inspection of this area. Look for S2319-61 Grommets and S2319 Cowl Fasteners that are pulled through. Also look on the doubler on the bottom side of the cowl for wear that has gone through the doubler and into the cowl.

**NOTE 6:** Turn the MS21059L3K nutplate as necessary to align the nutplate and to give an edge distance of no less than two fastener diameters.

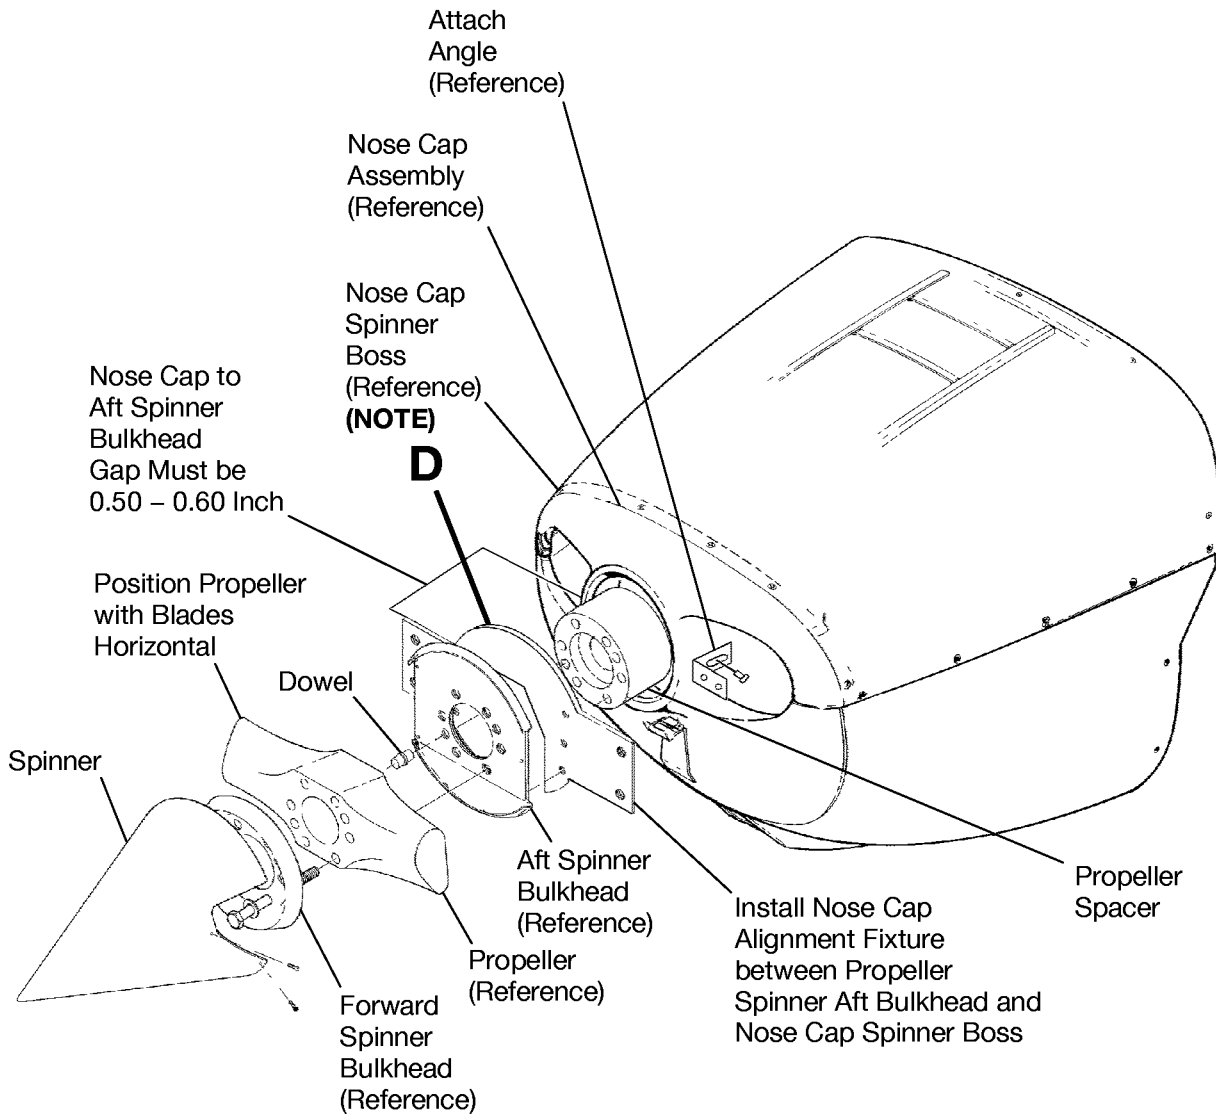
Figure 3. Nose Cap Alignment Fixture Installation (Sheet 3)

**NOTE:** The propeller spacer must be centered in the nose cap spinner boss opening.

- (3) (Refer to Figure 3, Detail C.) Move the nose cap assembly to center the nose cap spinner boss on the propeller spacer.
